Crime Prevention Through Environmental Design Principles and Civil Liability

By David R. Anderson

Case Example

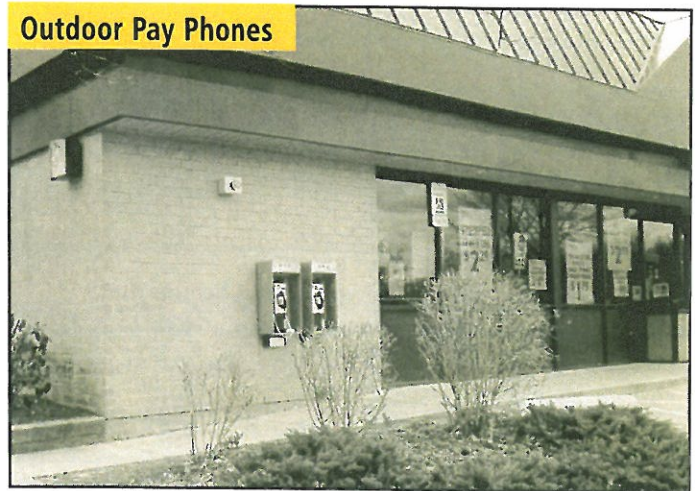
Outdoor Pay Phones

Problem: Outdoor payphones attract loiterers and can be the foundation for illegal drug dealing.

Solution: Locate payphones inside the store. Restrict phones to outgoing calls.
